## **Gabcikovo – 10 Years After the Conflict**

***24 October 2002 marked the 10<sup>th</sup> annual day for the operation of the Gabcikovo hydrodam system. For years, this project was one of the hottest water disputes in Europe but until today a conflict resolution is pending.***

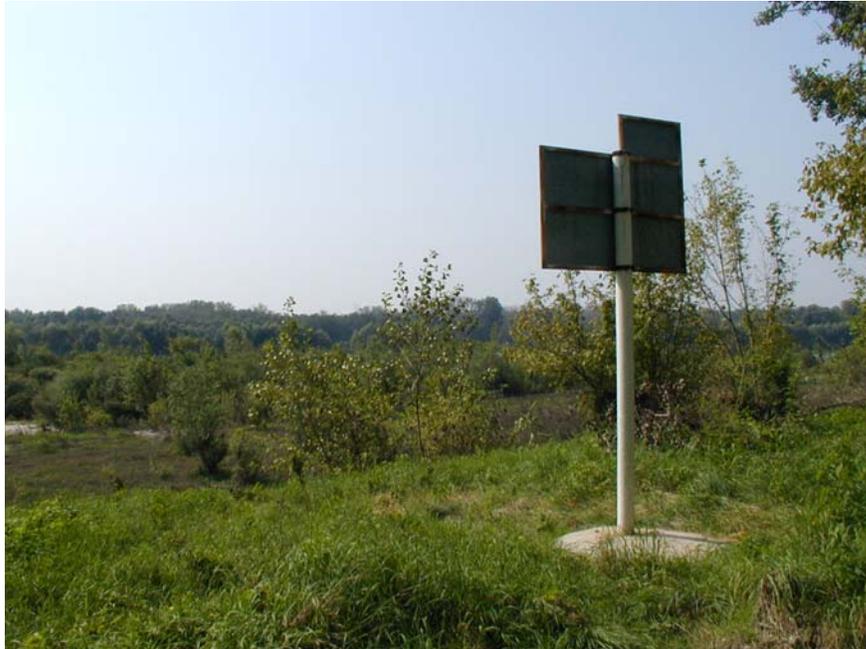
Photo 1: View into the “old” Danube river bed near Gabčíkovo, lacking over 80% of its discharge (© Zinke, 09/2002).

As a result, parts of the Danube bed and the extended side-arm system fell dry. In spring 1993, artificial irrigation systems started providing water for these floodplain biotopes on both sides of the river (altogether 8,000 hectares). However, numerous dikes and cross-barriers dissected the former open and interconnected ecosystem into separated parts. The Danube lost its function as a “life pump” regularly moistening and draining the riparian landscape. The stabilisation of formerly very dynamic hydrological and morphological processes led to a continuous degradation, with many forest areas drying up and fisheries receding, with rare pioneer habitats and species having gone. Also the former purification effects for Danube waters through the filtering process in the rich vegetation and soils are lost today.

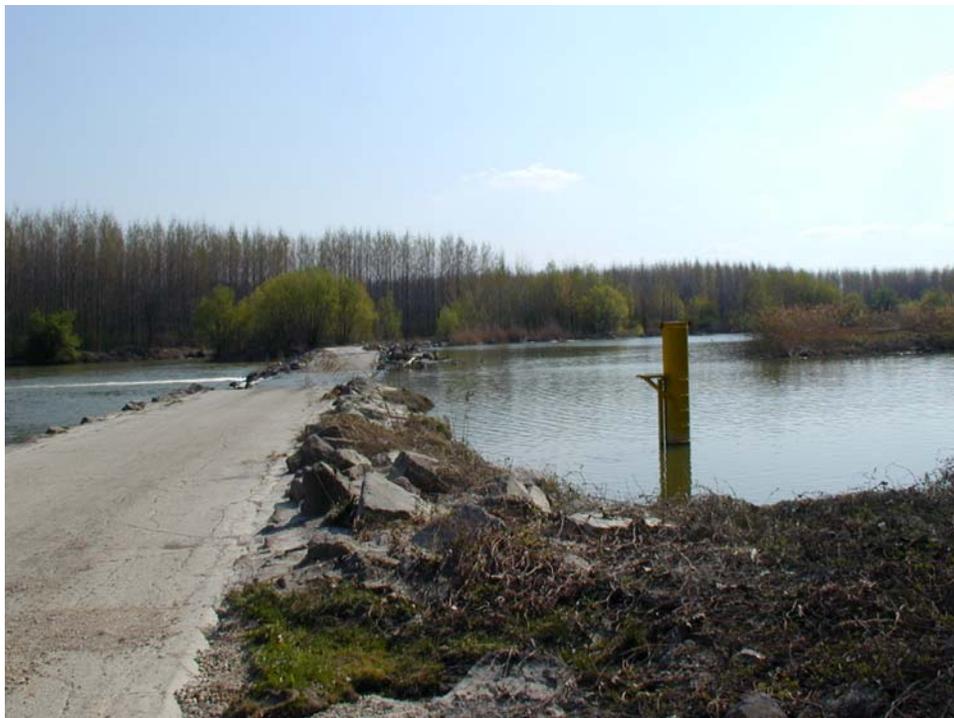
Photo 2: The formerly open side-arm system is since end of 1992 disconnected from the river and, here on Slovak side, turned into a system of artificially irrigated and stabilised cassettes (© Zinke, 04/2002).
